Kiwa PVEL Breaks It Down

Understanding the Impacts of Cell Cracks & Glass Breakage

Tristan Erion-Lorico Kiwa PVEL

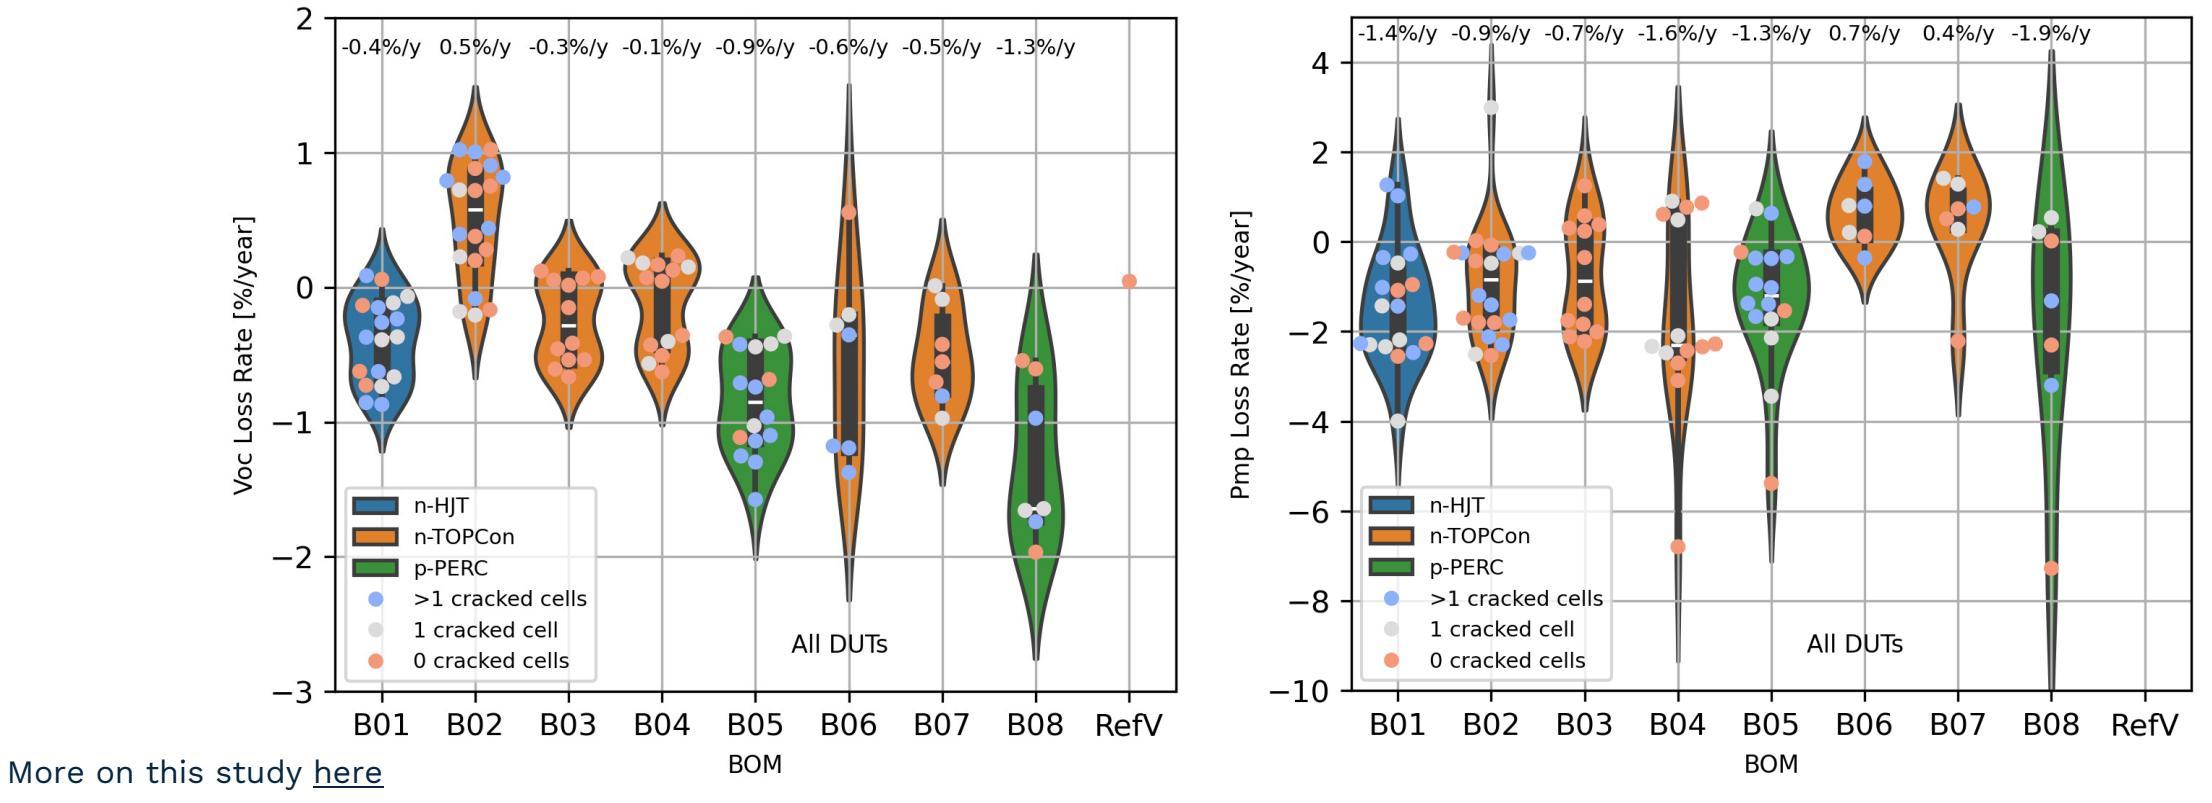
Cell Cracks – Results So Far

- Voc and Pmp loss rates are similar for modules with and without cracked cells.
- Voc loss rate for TOPCon and PERC BOMs is less than 0.5%/yr thus far.
- However, many modules exceed 2% power degradation in first year (even control samples).

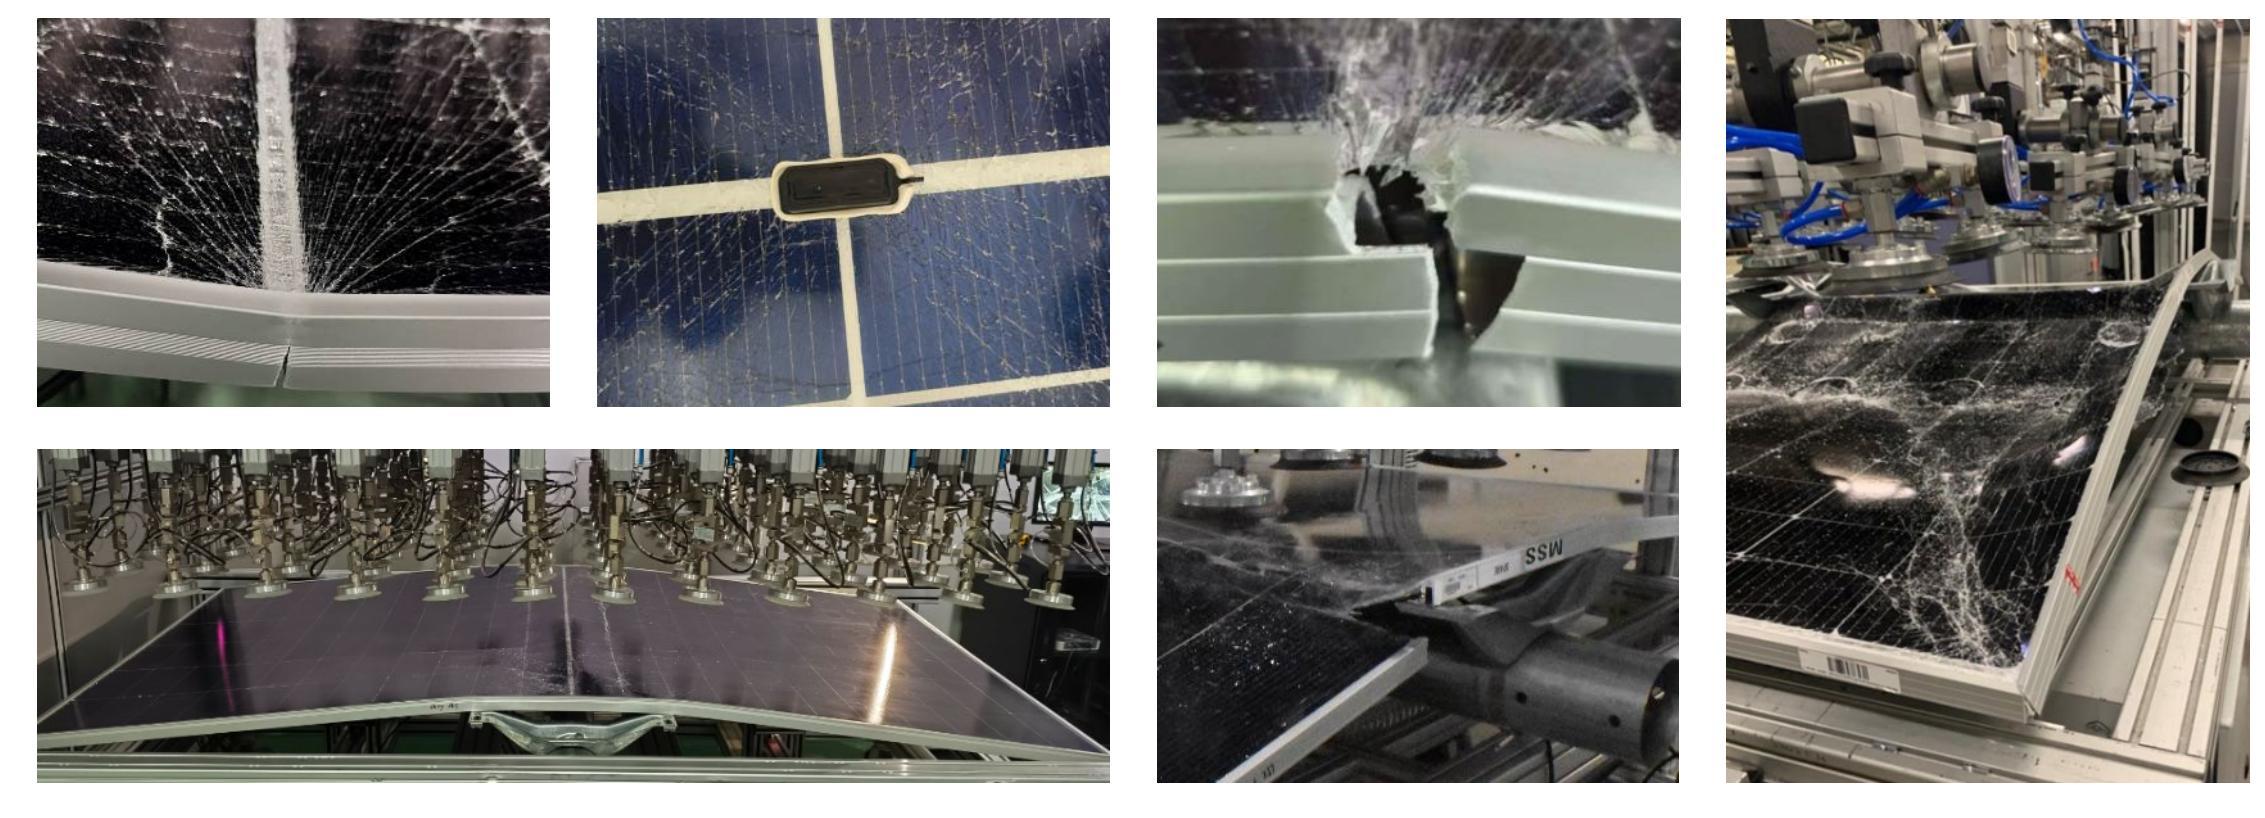
Broken Modules – No Shortage of Examples

- As will be reported in the 2025 PV Module Reliability Scorecard (<u>www.scorecard.pvel.com</u>):
 - **20% of BOMs** undergoing the PQP's Mechanical Stress Sequence experience broken glass or frames.
 - 40% of manufacturers experienced at least one failure during MSS testing

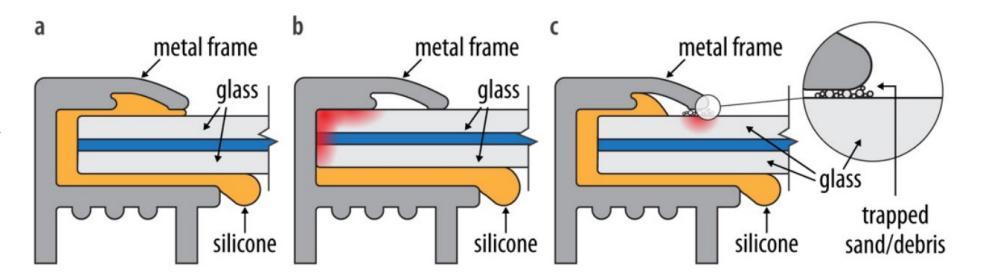
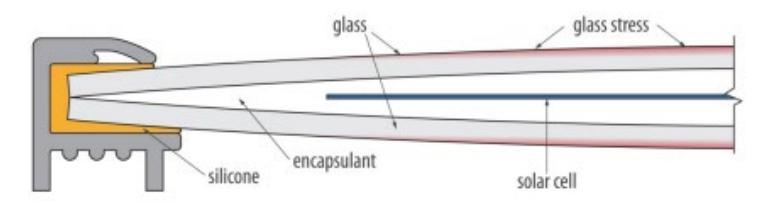
- Kiwa's analysis of broken modules from the lab and field supports NREL's recent work¹ on this topic.
- A range of possible causes have been identified:
 - reduced glass strengthening
 - flaws within the glass edge and junction box mounting holes
 - weaker frame designs
 - more aggressive module mounting
 - contact between the glass and frame
 - laminate edge pinch
 - larger module areas
