# The biggest reliability risks facing today's modules

## *Insights from Kiwa PVEL's PQP testing*

**SAYURI-PV 2025**

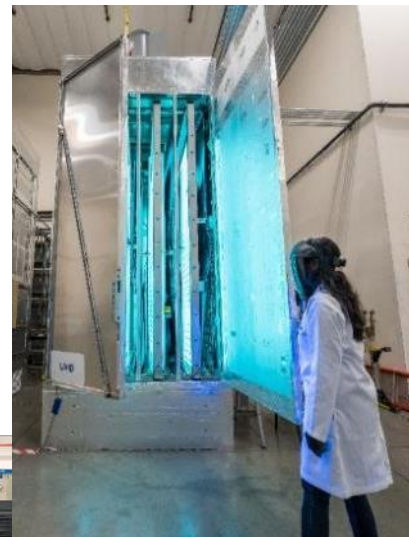
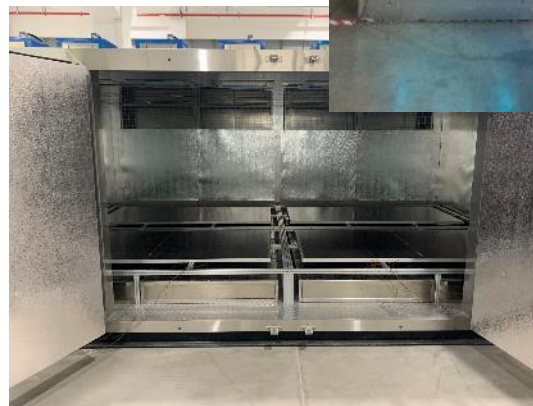
- UV Testing with **front-side exposure**, 60°C, short-circuit condition.
- UV exposure dose **120 kWh/m<sup>2</sup>** of UV (280-400 nm) **when using metal-halide lamps** or 53 kWh/m<sup>2</sup> when using UV fluorescent lamps.

UV 60 kWh/m<sup>2</sup>  
60°C front

Characterization

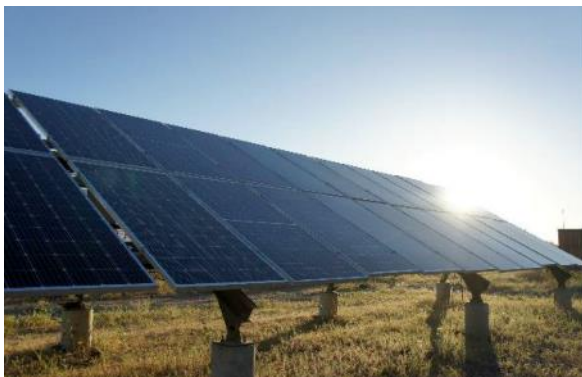
## Field Exposure (FE) Results at a Glance

- PVEL performs 1 year outdoor exposure in Davis, CA. Modules installed in 2023 and 2024.
  - TOPCon modules analyzed only.
  - Each project has its own control module kept in dark storage during exposure.
- **1 year Pmp degradation has a median of -2.2%**
  - Combined indoor LID & LETID Pmpp loss <1%.

- Most would **not meet a <1.0% degradation warranty** at the end of year 1.

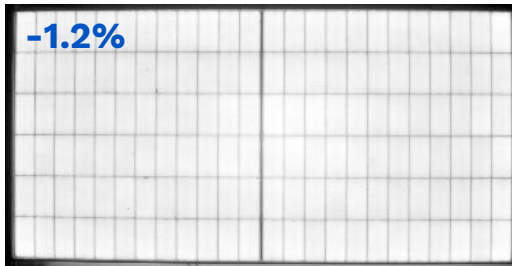
## Field Exposure Results, Signs of UVID (Checkerboarding)

- For many modules, UVID signature is clearly visible in EL post 1 year exposure.
  - Somewhat random selection of 6 recent FE projects

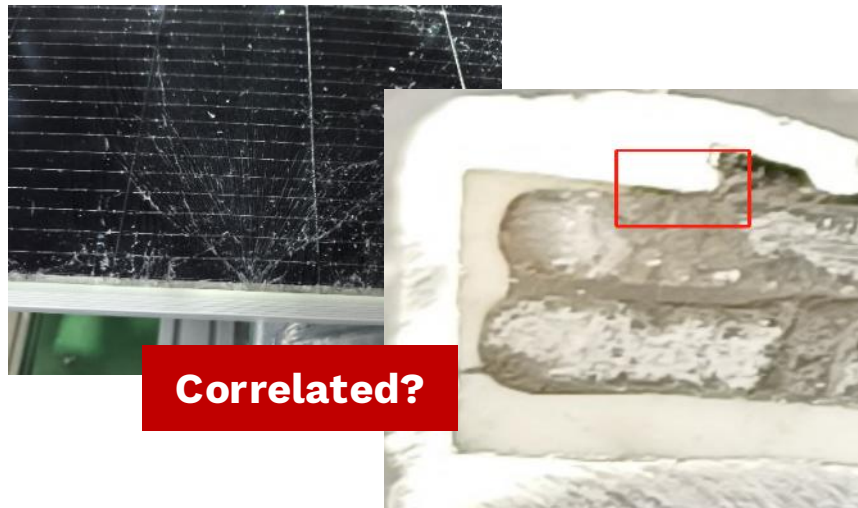
## #1 Mechanical Breakage Risks at their Highest

- Steep increase in SML and DML failure rates observed over the past 18 months.
- “Leading” failure mode appears to be glass breakage (front and/or rear) due to pinching.
  - Took over frame failures during 2024-2025 period

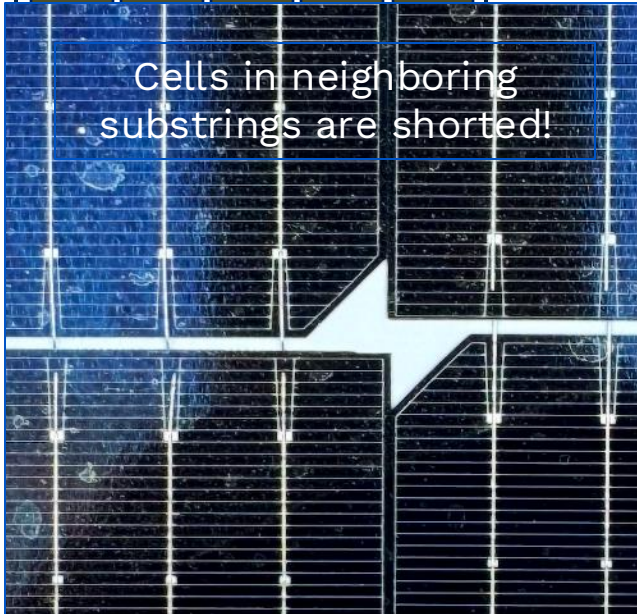
## #5 Keep your distances!

- Manufacturers are increasing the size of cells but not changing laminate size.
  - Done to improve module efficiency.
  - Technically possible to achieve the creepage distances but...
  - ~0.2mm tolerances on layout hard to achieve for many manufacturers
- May create increase **safety risks** in the field:
  - Cell shorting, heating & glass breakage.
  - DC arcing events.

IEC 61730-1 required 10.4 mm from energized circuit to laminate edge (1500V system voltage)
